8XC152JX

SPECIFICATION UPDATE

Release Date: July, 1996

Order Number: 272882-001

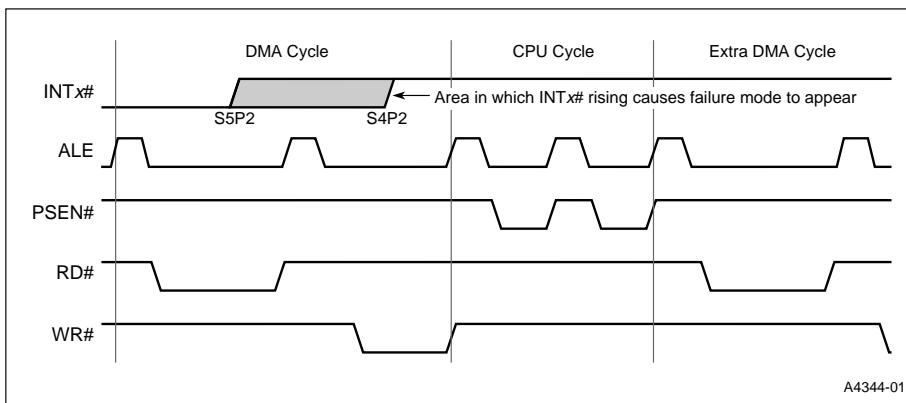
PROBLEM: On the 8XC152JA/JB/JC/JD, a failure mode occurs by using either DMA channel in level-sensitive, external demand mode. If, after a transfer begins, the INTx pin goes high between S5P2 and S4P2 of a DMA cycle, an extra DMA transfer will take place.

IMPLICATION: The condition above applies to all single-machine-cycle transfers. All DMA transfers take one machine cycle except the external-external transfer which takes two. For this mode, the bug appears only if INTx goes high between S5P2 of the first machine cycle, and S4P2 of the second.

WORKAROUND: At this point there are no known software or hardware workarounds. The following diagram gives a graphical description of the anomaly.

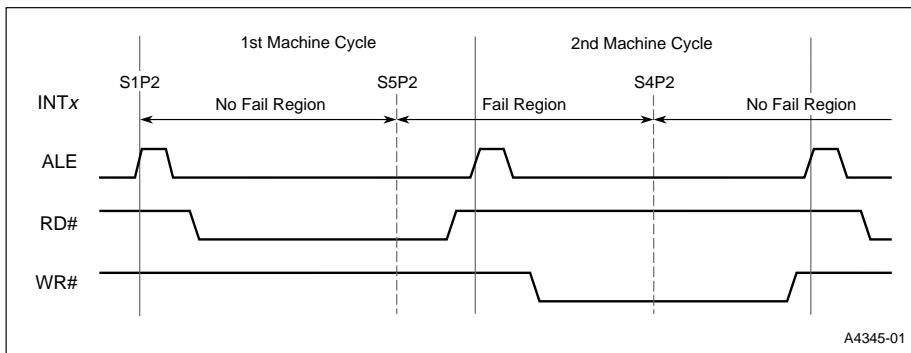
**External to External Transfer (1 Transfer Shown)**

The diagrams below illustrate the areas of a DMA transfer during which the rising edge of the INTx pin will and will not cause the bug to appear. Each of the four transfer modes are shown.
